Archeological Testing
at the Proposed Location
of the Museum Storage Facility
Colonial National Historical Park
Yorktown, Virginia

Allen H. Cooper
National Park Service
Philadelphia Support Office
1998

Management Summary

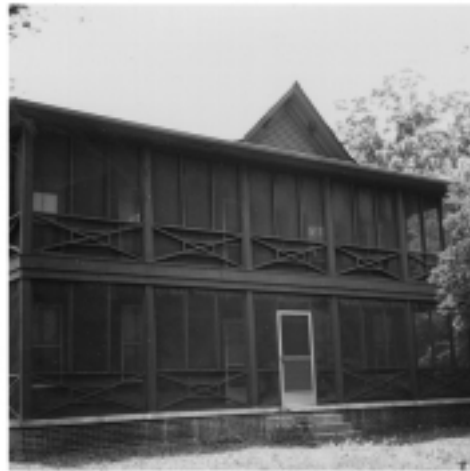
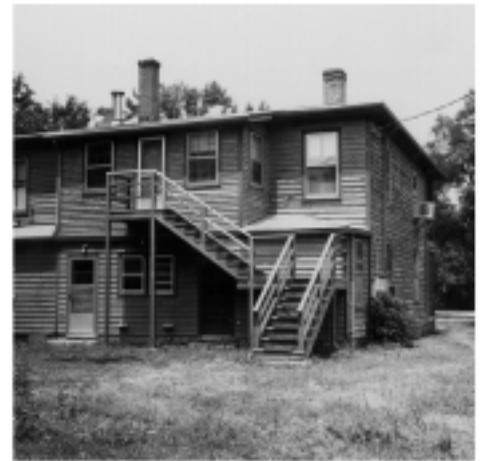
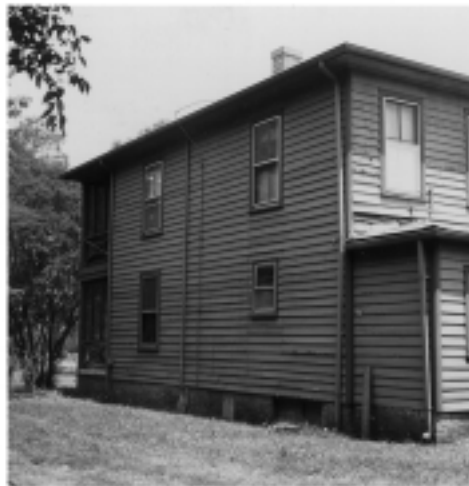
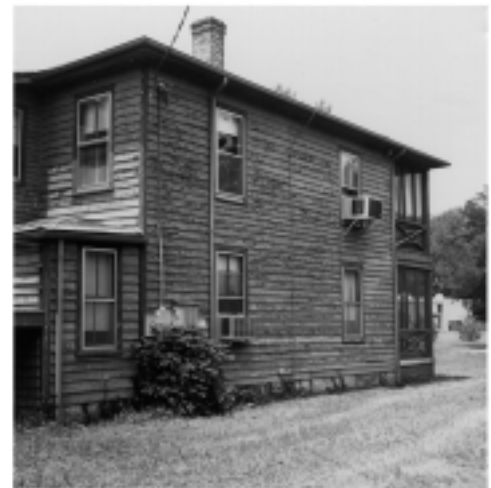
Figure 2: Photographs of Quarters 211 Prior to Demolition.

Colonial National Historical Park has proposed the construction of a new museum storage facility adjacent to the existing maintenance facility, located just west of U.S. Route 17 (Figure 1). The location of the proposed development is the former site of Quarters 211 (Figure 2). Constructed around 1870, Quarters 211 was a five-bay two story dwelling with an Italianate roof. Used for park housing from its purchase in 1931 until the early 1980's, the structure was demolished in 1993. An unpaved parking area was once located adjacent to the existing paved road. It was removed at an unknown date.

North Facade

South Facade

East Facade

West Facade

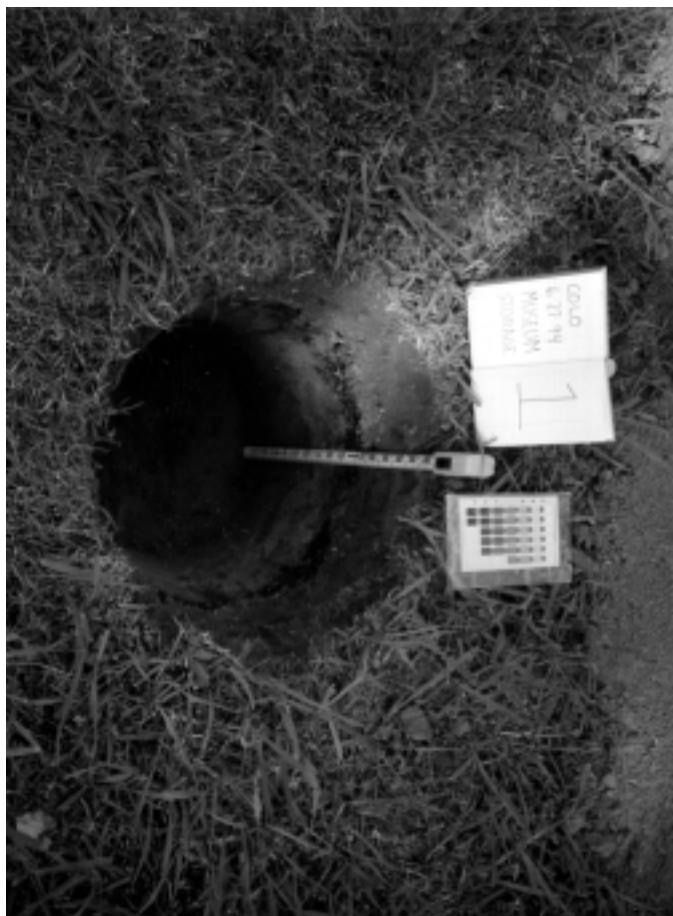
Figure 6: Test 1.

The original stratigraphy, as identified in Tests 1 and 5, has two strata; a surface layer of dark grey sandy loam (Munsell (10YR 4/1) extending to 0.4 feet, followed by brown clayey sand (Munsell 10YR 5/3) grading into yellowish brown sandy clay (Munsell 10YR 5/4). The depth of this transition varies as illustrated in Figure 3 and reflects the slight elevation

0 to 0.4'	Dark grey sandy loam (Munsell 10YR 4/1)
0.4 to 1.5'	Brown clayey sand (Munsell 10YR 5/3) grading into yellowish brown sandy clay (Munsell 10YR 5/4)

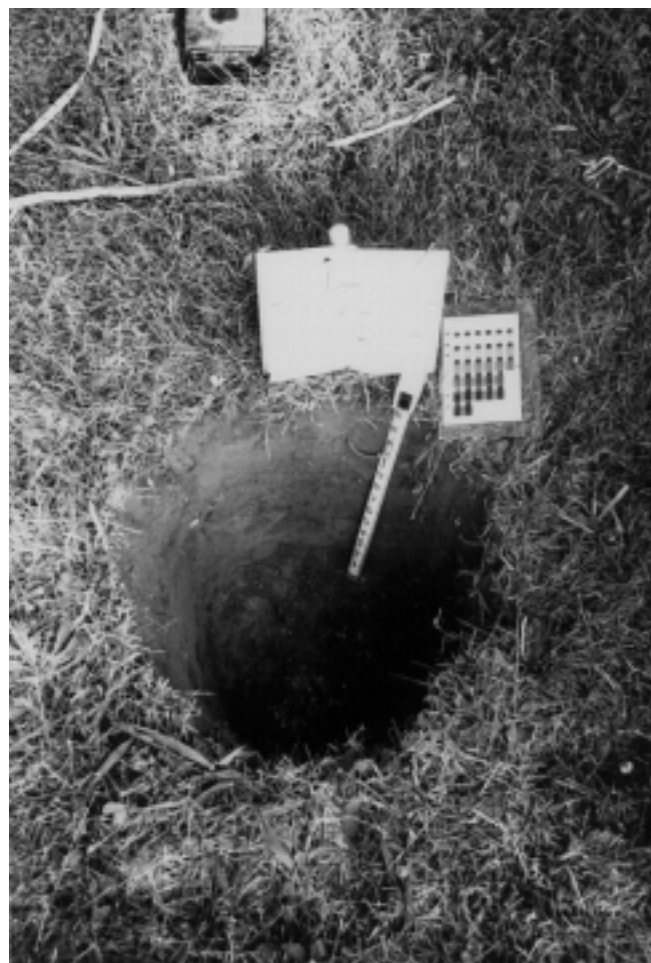
Figure 7: Test 2.

0 to 1.0'	Dark grey sandy loam (Munsell 10YR 4/1)
1.0 to 1.4'	Brown clayey sand (Munsell 10YR 5/3) grading into yellowish brown sandy clay (Munsell 10YR 5/4)

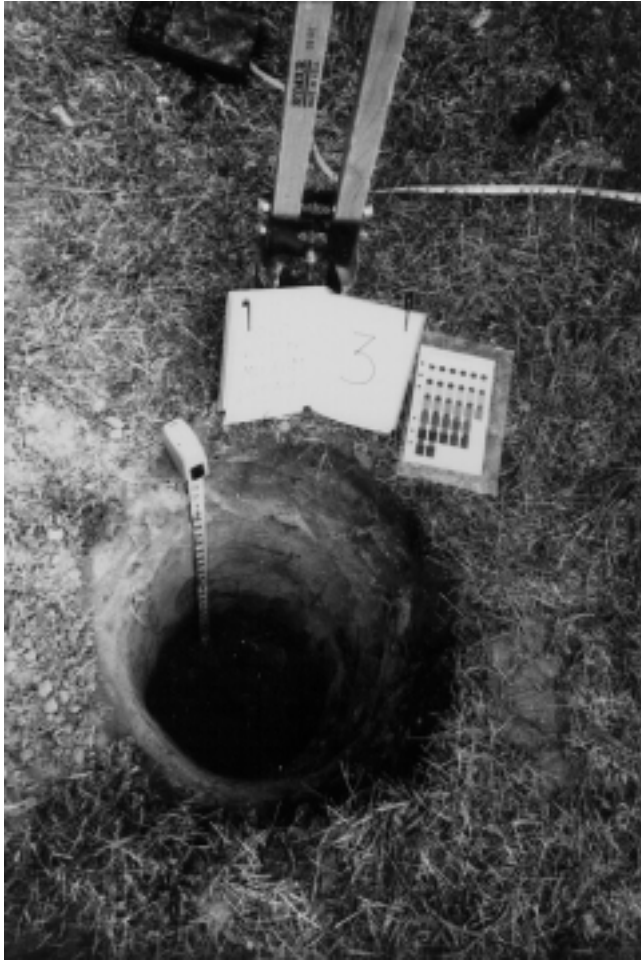
Figure 8: Test 3.

Test 3 contained the single artifact which was not recovered from an undisturbed context, a single Madison pp/k from the upper portion of Strata 3.

0 to 0.2' Dark grey sandy loam (Munsell 10YR 4/1)

0.2 to 0.6' Yellowish brown clay (Munsell 10YR 5/6)

0.6 to 2.1' Brown clayey sand (Munsell 10YR 5/3) grading into yellowish brown sandy clay (Munsell 10YR 5/4)

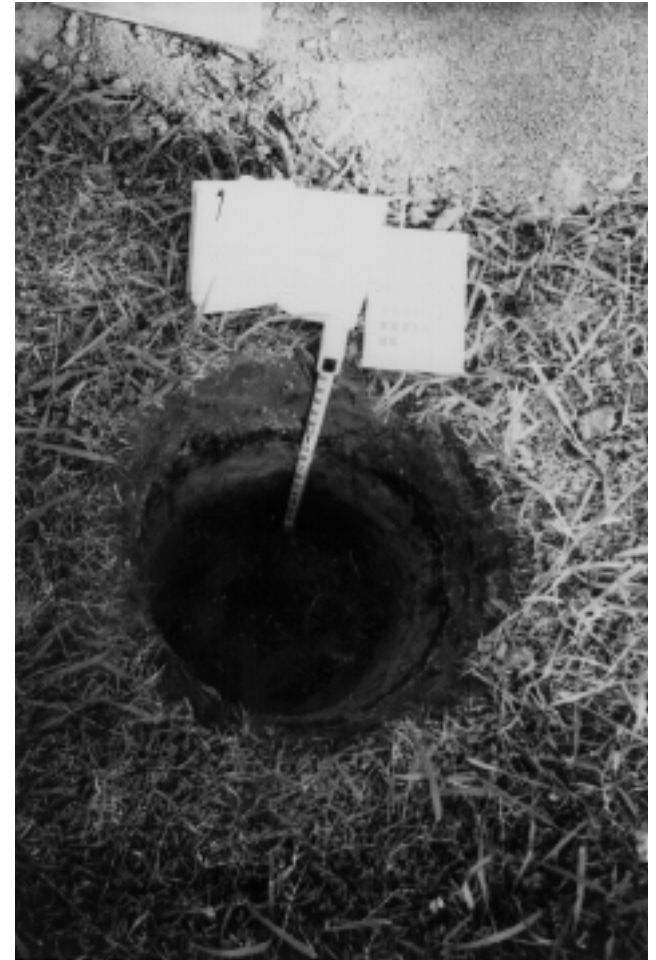
Figure 9: Test 4.

0 to 0.4'	Dark gray sandy loam (Munsell 10YR 4/1)
0.4 to 0.8'	Black cinder and shell (Munsell 10YR 2/1)
0.8 to 1.6'	Brown clayey sand (Munsell 10YR 5/3) grading into yellowish brown sandy clay (Munsell 10YR 5/4)

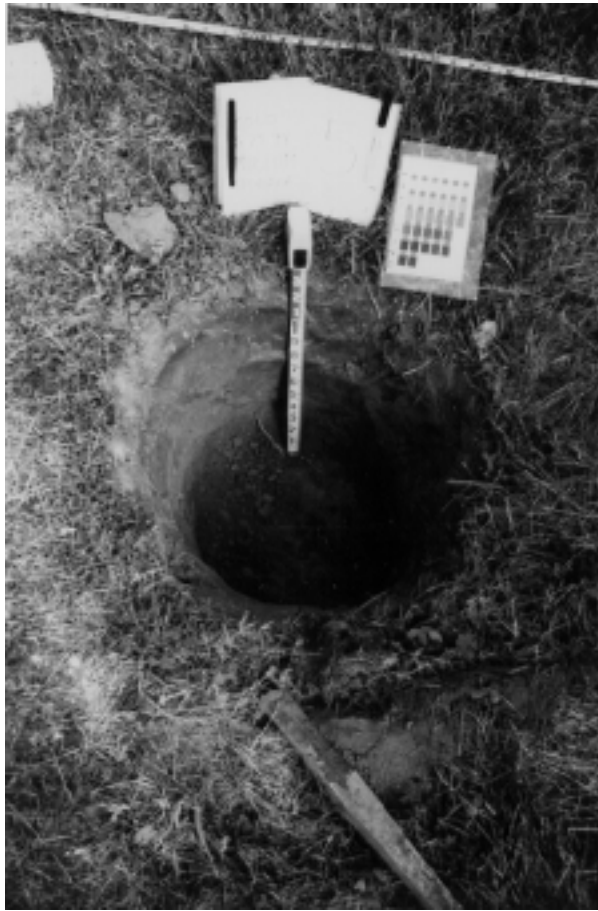
Figure 10: Test 5.

0 to 0.3'	Dark grey sandy loam (Munsell 10YR 4/1)
-----------	---

0.3 to 1.3' Brown clayey sand (Munsell 10YR 5/3) grading into yellowish brown sandy clay (Munsell 10YR 5/4)

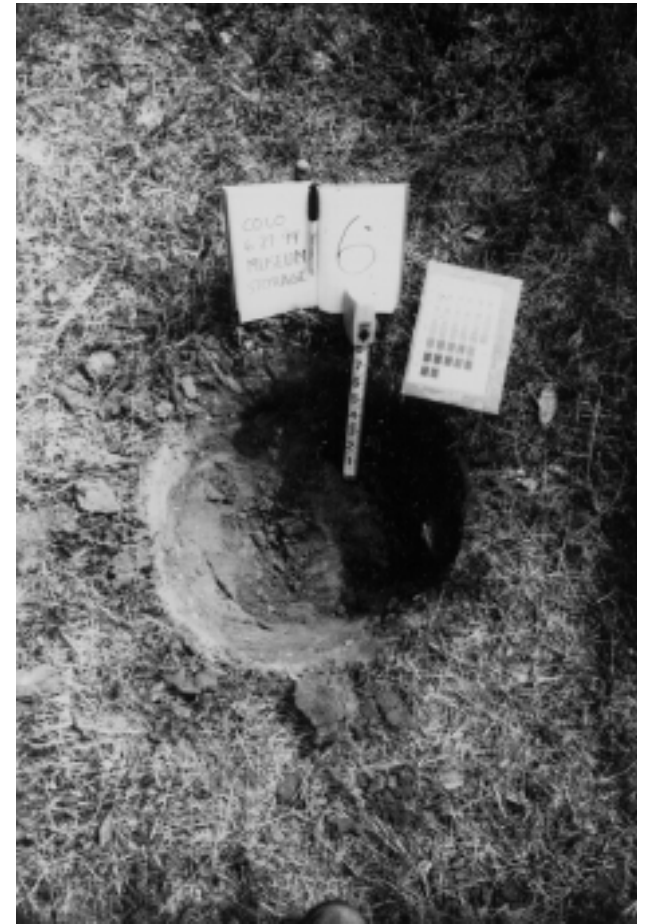
Figure 11: Test 6.

0 to 0.4' Dark grey sandy loam (Munsell 10YR 4/1)

0.4 to 0.7' Yellowish brown clay (Munsell 10YR 5/6)

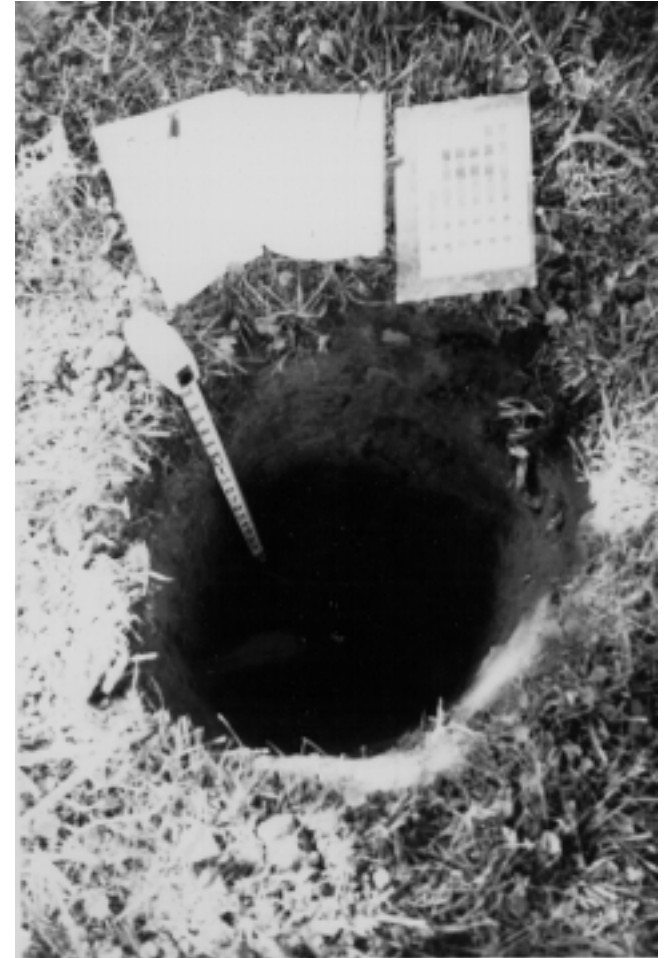
Figure 13: Test 8.

0 to 0.3' Dark grey sandy loam (Munsell 10YR 4/1)

0.3 to 1.0' Yellowish brown sand (Munsell 10YR 5/4)

1.0 to 1.75' Brown clayey sand (Munsell 10YR 5/3) grading into yellowish brown sandy clay (Munsell 10YR 5/4)

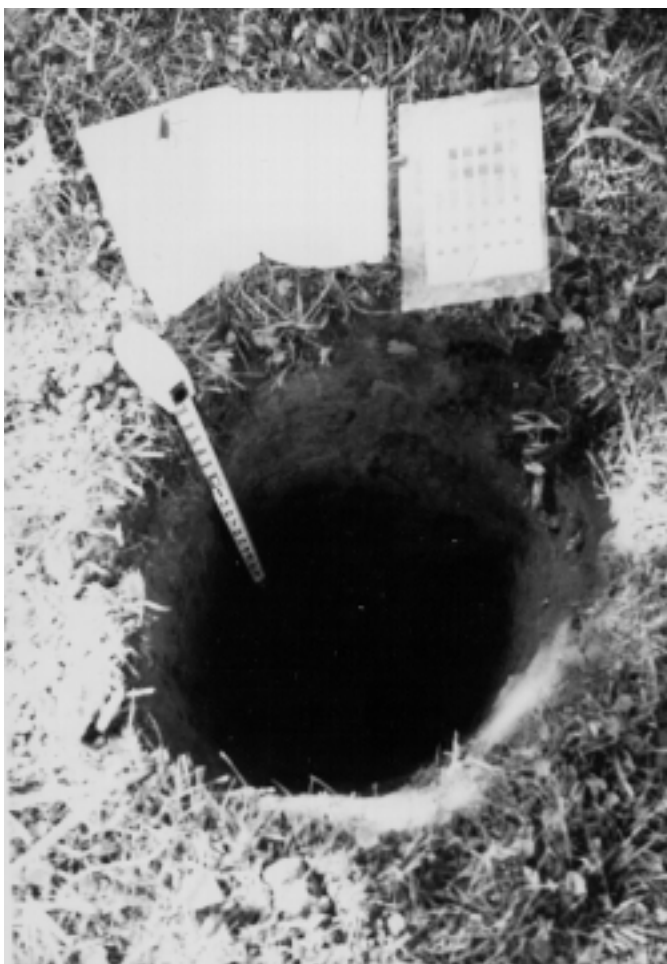
Figure 14: Test 9.

0 to 0.2' Dark grey sandy loam (Munsell 10YR 4/1)

0.2 to 0.9' Yellowish brown clay (Munsell 10YR 5/6)

0.9 to 2.2' Brown clayey sand (Munsell 10YR 5/3) grading into yellowish brown sandy clay (Munsell 10YR 5/4)

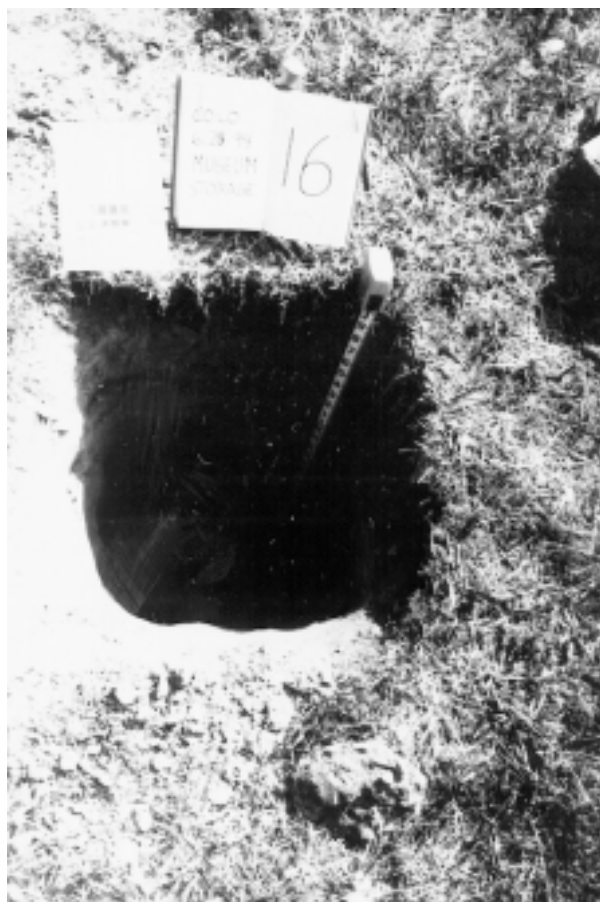
Figure 16: Test 16.

0 to 0.3'	Dark grey sandy loam (Munsell 10YR 4/1)
0.3 to 1.4'	Yellowish brown clay (Munsell 10YR 5/6)
1.4 to 2.9'	Brown clayey sand (Munsell 10YR 5/3) grading into yellowish brown sandy clay (Munsell 10YR 5/4)

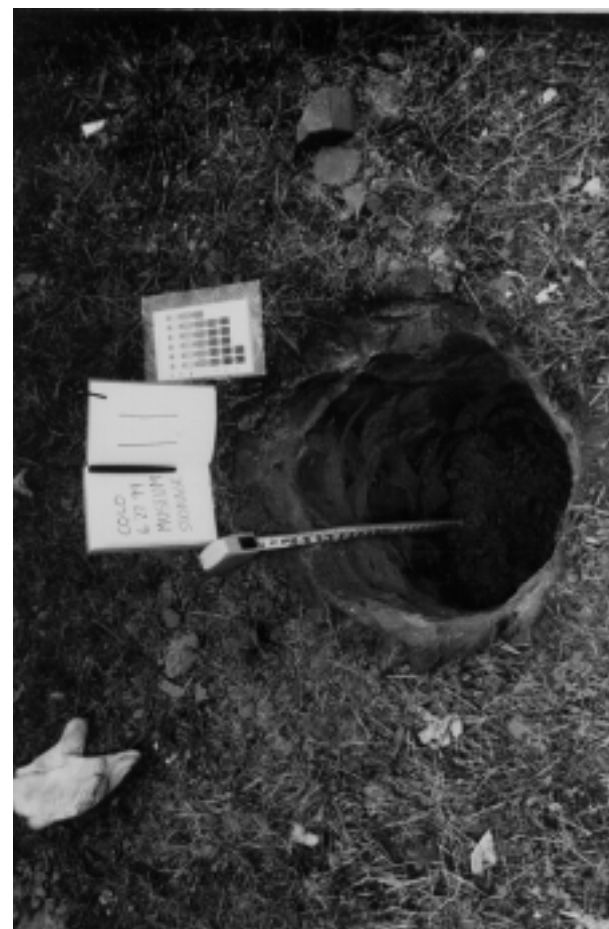
Figure 17: Test 12.

0 to 0.2'	Dark grey sandy loam (Munsell 10YR 4/1)
0.2 to 0.8'	Yellowish brown clay (Munsell 10YR 5/6)
0.8 to 2.2'	Brown clayey sand (Munsell 10YR 5/3) grading into yellowish brown sandy clay (Munsell 10YR 5/4)

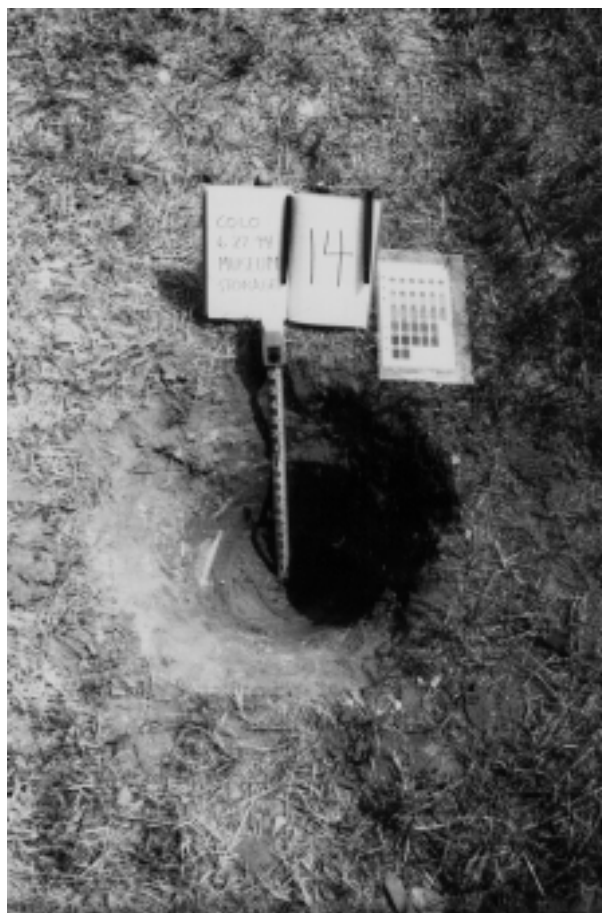
Figure 18: Test 14.

0 to 0.2'	Dark grey sandy loam (Munsell 10YR 4/1)
0.2 to 1.0'	Yellowish brown clay (Munsell 10YR 5/6)
1.0 to 1.6'	Brown clayey sand (Munsell 10YR 5/3) grading into yellowish brown sandy clay (Munsell 10YR 5/4)

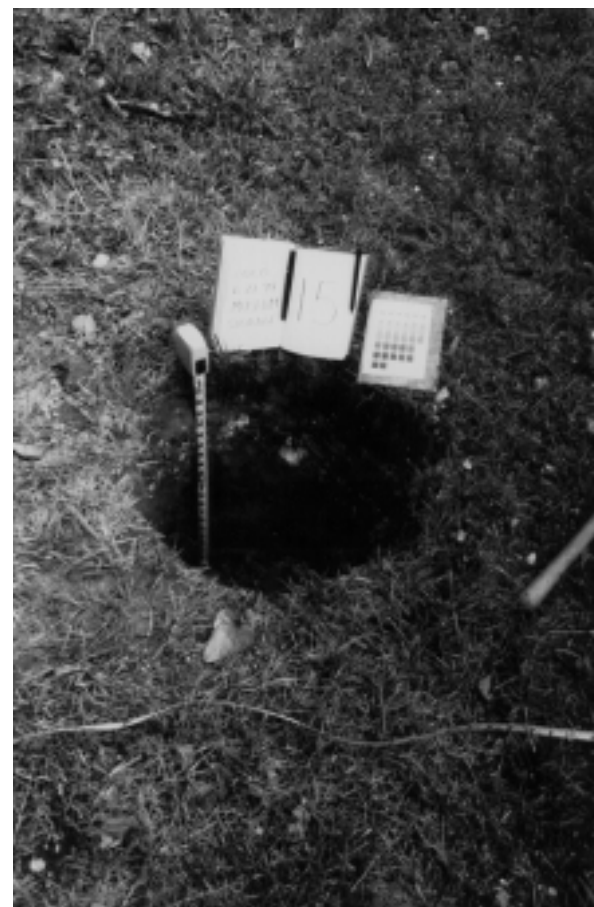
Figure 19: Test 15.

0 to 0.3'	Dark grey sandy loam (Munsell 10YR 4/1)
0.3 to 1.0'	Yellowish brown clay (Munsell 10YR 5/6)
1.0 to 2.0'	Brown clayey sand (Munsell 10YR 5/3) grading into yellowish brown sandy clay (Munsell 10YR 5/4)
